Stock Condition Survey

44 Check Street
Test Avenue
City
1234

FIGURE 1 FRONT ELEVATION OF PROPERTY - 44 CHECK STREET, COULDSON, SURREY, CR5 2BG

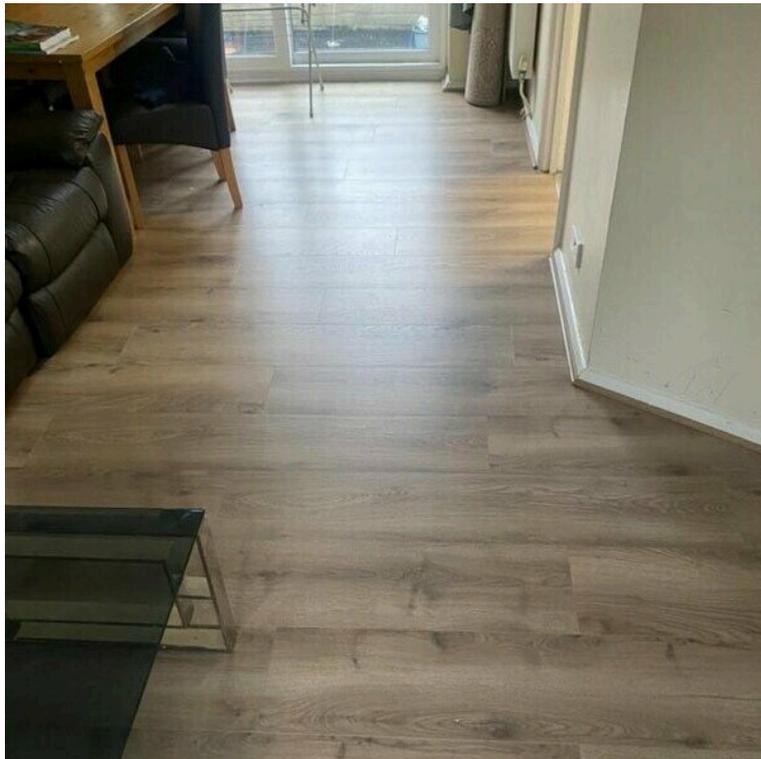
Photograph 6

11 Floors	<p>Carpet and vinyl floor coverings are in reasonable condition. Additional isolated scratches and soiling were observed.</p> <p>Skirting boards are in good condition.</p>	6, 10	
12 Dampness/Penetrating/Condensation	<p>Damp is evident in the property. While the tenant is managing the issue, it is recommended that Croydon Affordable Homes takes responsibility for addressing the problem to ensure complete eradication of the damp.</p> <p>Allow cost to instruct damp specialist to undertake survey to identify the source of damp prior to specifying remedial works.</p>	12, 19	£250
13 Internal Joinery	<p>Joinery is generally in fair condition commensurate with age and use. Door frames are beginning to deteriorate in areas.</p> <p>However, not of serious concern in the short term.</p>		
14 Kitchen Fittings	<p>The kitchen is in fair repair and condition.</p> <p>Allow for extractor fan to be installed to kitchen.</p> <p>Install plinth beneath kitchen units.</p> <p>Undertake ease and adjusting to cupboard doors and drawers.</p> <p>Fixtures and fittings are affected by damp. Allow to dry space prior to carrying redecorating.</p>	7, 9, 11	£900
